Inspection Report No: 3932

**Client Name: First National Engage Eastlakes**  
**Property Address: 21 Master Street, Belmont North.**

The Standard Property Report (Except ACT) Complies with Australian Standard  
AS 4349.1- 2007 Inspection of Buildings Part 1: Pre-Purchase Inspections –  
Residential Buildings

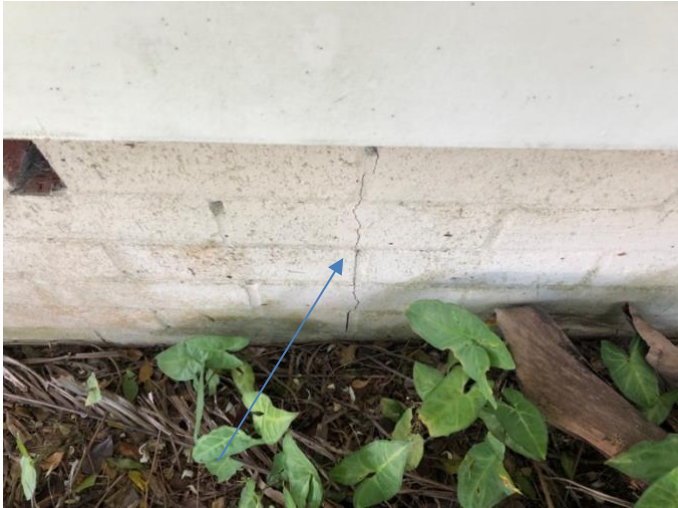
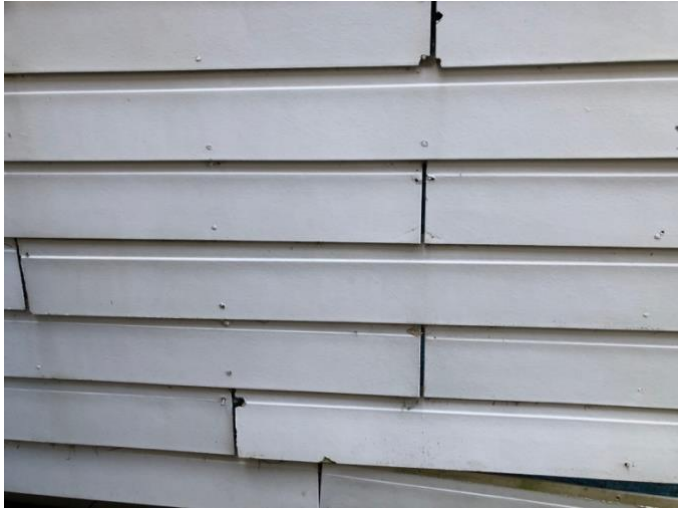
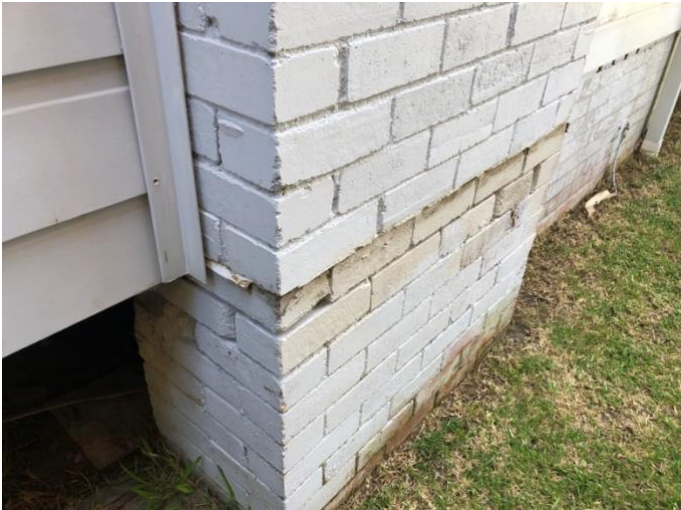
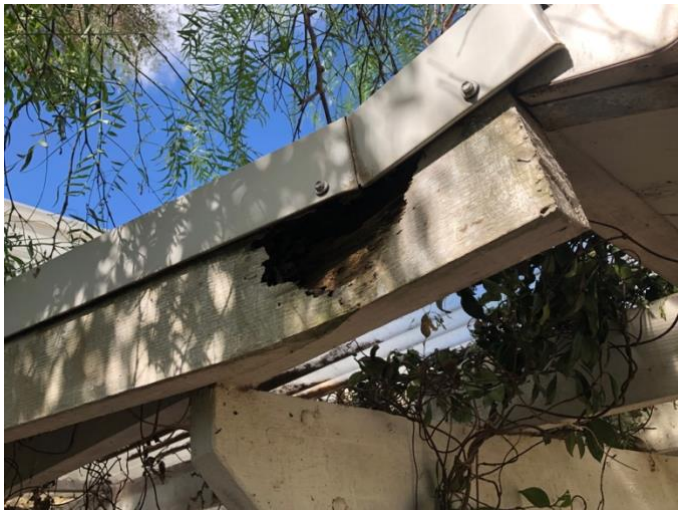
- Corroded upper downpipe bend noted.
- Minor cracking noted to the sub-wall brickwork (typical). (Photo page 6)
- Loose perimeter decking board, minor repair recommended asap; beware of trip hazards. Decking boards have also been laid upside down.
- Weatherboard and moulding defects as per the summary.
- Corroded fixings noted to the balcony balustrades; strongly consider reinstating with galvanized fixings. (Photo page 7)

- Meter box; safety switches protect selected power circuits only.
- Weatherboard and moulding defects as per the summary. (Photo page 6)
- 125lt electric HWS; date of manufacture 07/07. Exposed wiring noted at base of unit, cover requires reinstating. Consult a licensed electrician.
- LPG gas provisions.
- Minor settlement noted to the chimney structure including minor fretting to the sub-wall below the dampcourse level. (Photo page 6)
- Degrees of corrosion noted to the chimney flue.
- Remove Bangalow palms adjacent the SW corner of the building to prevent future structural issues the building foundations.

- Weatherboard and moulding defects as per the summary.
- Area of significant decay to pergola barge and end rafter. (Photo page 6)
- Thorough cleaning required to the pergola roof guttering including reinstatement due to sag issues. (Photo page 7)
- Expose the bases of the pergola posts to prevent future decay issues.

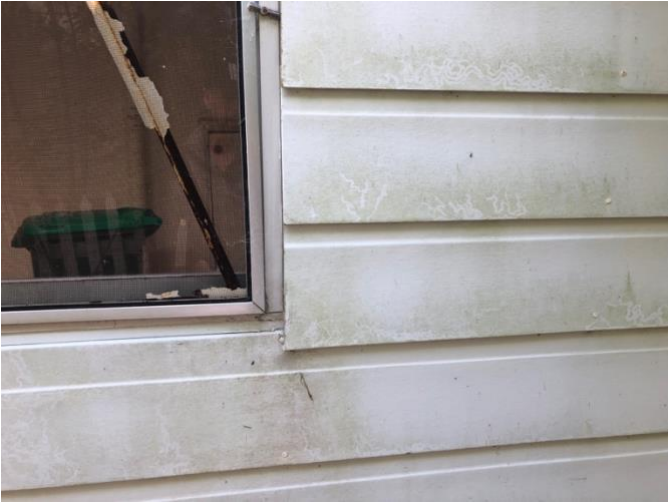
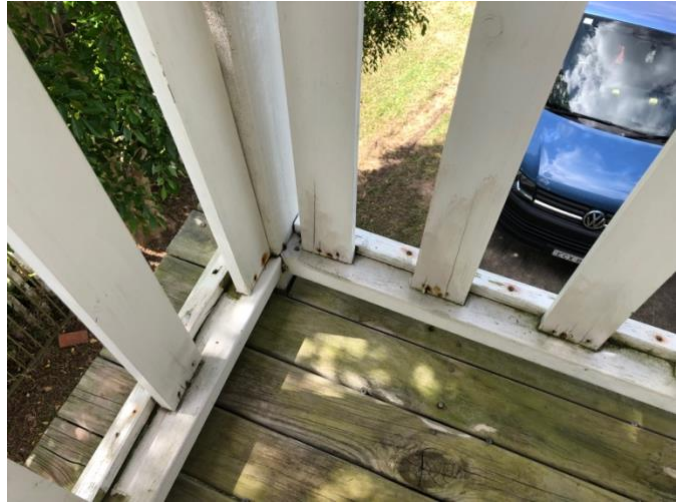
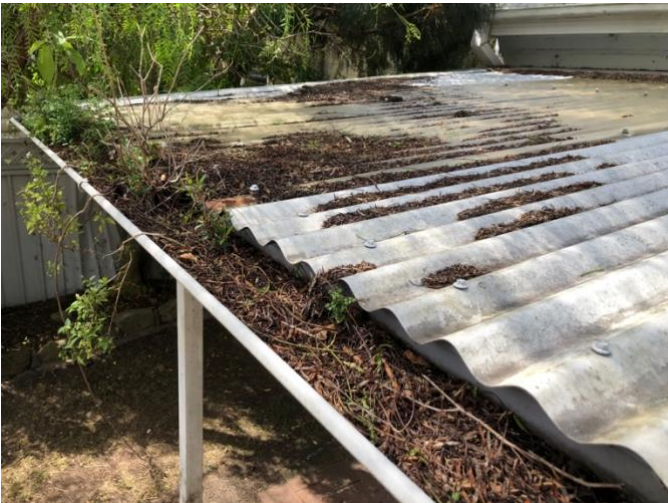
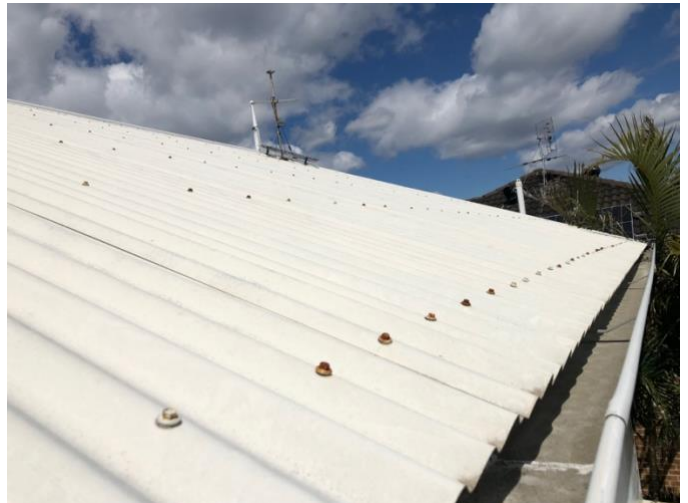
- Weatherboard and moulding defects as per the summary. (Photo page 7)
- Corroded AC brackets noted, consider replacing in the short term.

- The roof sheets appear in generally good serviceable condition. (Photo page 7)
- Gutters and downpipes appear in generally good serviceable condition.

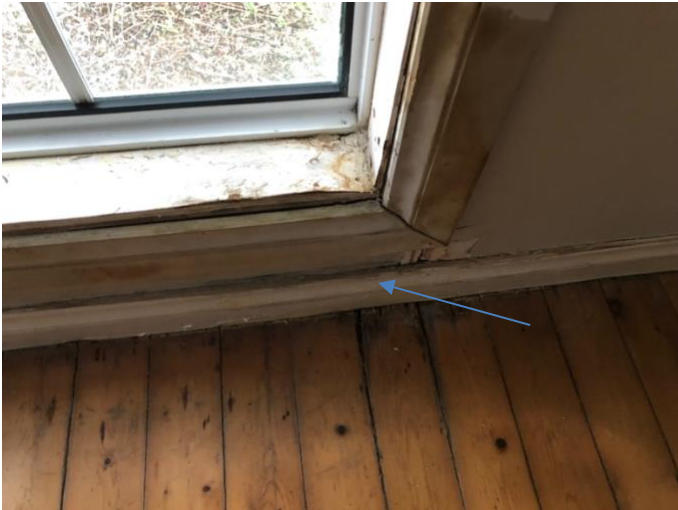
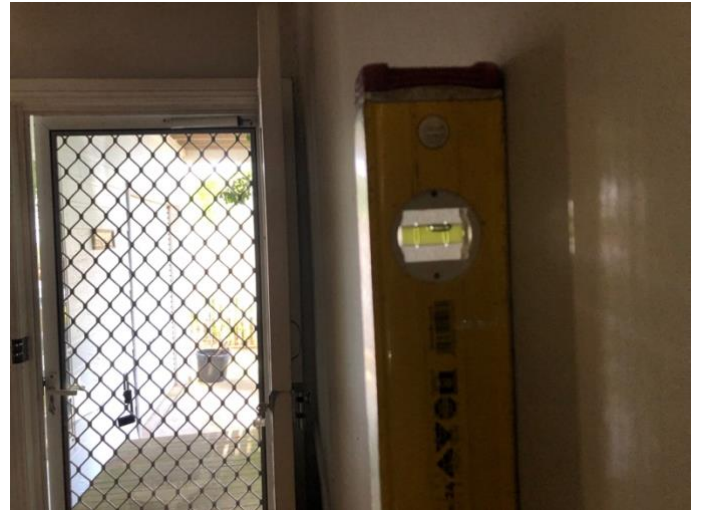
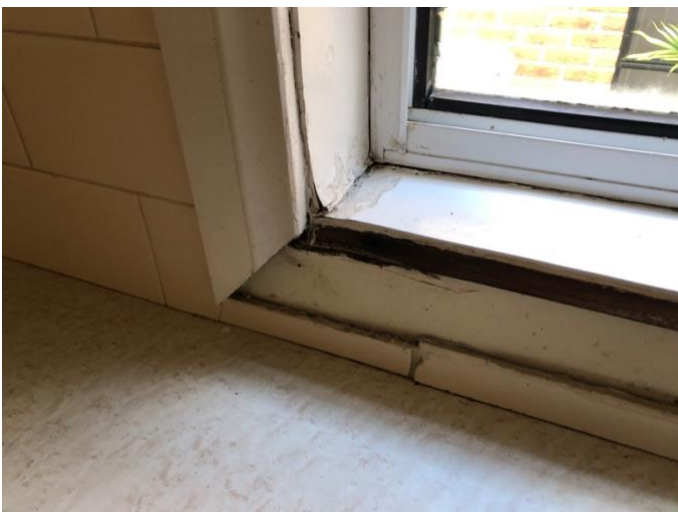
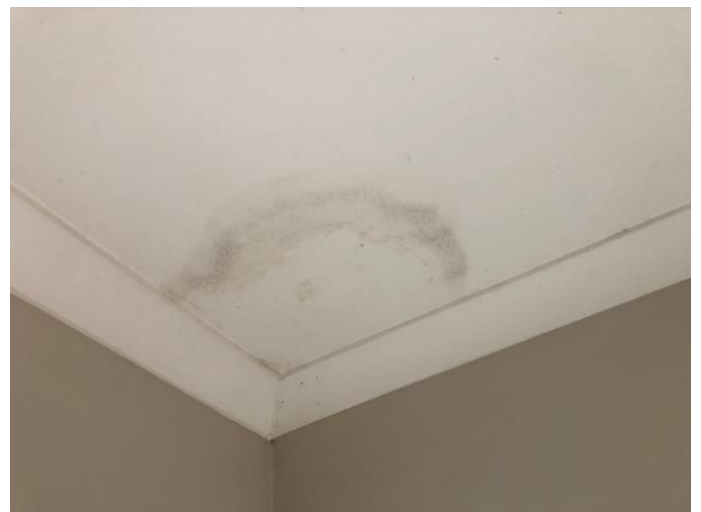
- Minor to significant floor level deviations noted to pier settlement as per the summary.
- Vertical plumb deviations noted to the front perimeter wall frame. (Photo page 10)
- Water damage to window reveals due to flashing defects as per the summary. (Photo page 10)
- Minor cracking noted adjacent window openings.
- Water damage noted to the base of the entry door.
- Paint peeling to ceilings.

- Benchtops, cupboards doors and drawers appear in generally serviceable condition despite minor to significant wear and tear.
- Non-ducted Rangehood.
- Water damage to window reveals due to flashing defects as per the summary.
- Water escape noted from the sink mixer.
- Water escape noted from the upper ensuite via ceiling downlights. Water stains also noted to ceiling linings. (Photo page 10)

**The majority of windows displayed evidence of significant water entry via defective or absent flashings. Significant swelling/water damage was noted to the MDF and pine reveals. Allow to remove windows and reinstate flashings/mouldings. Consult a licensed builder.**

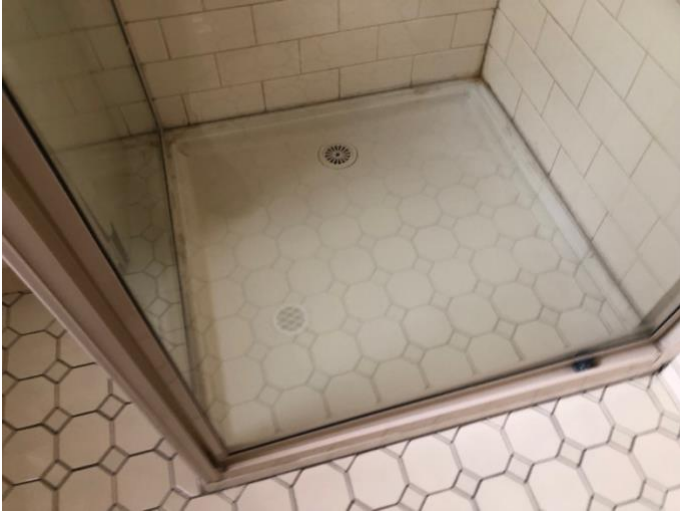
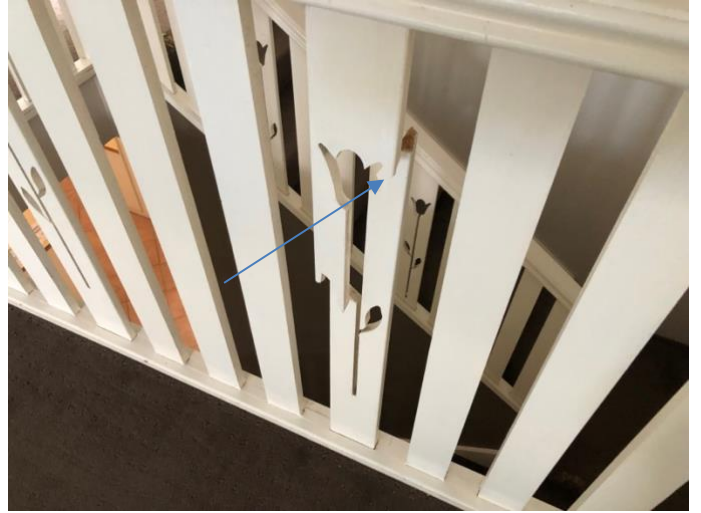
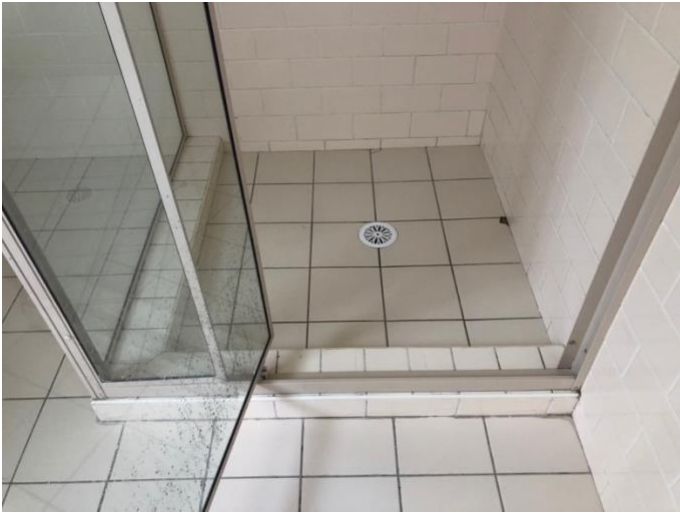
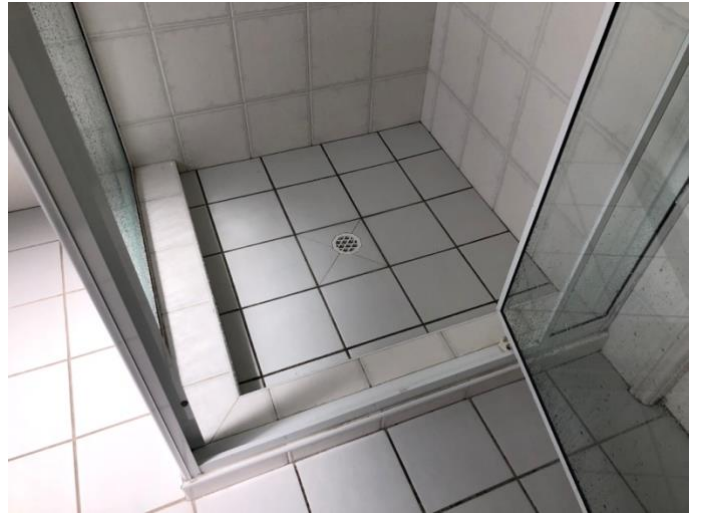
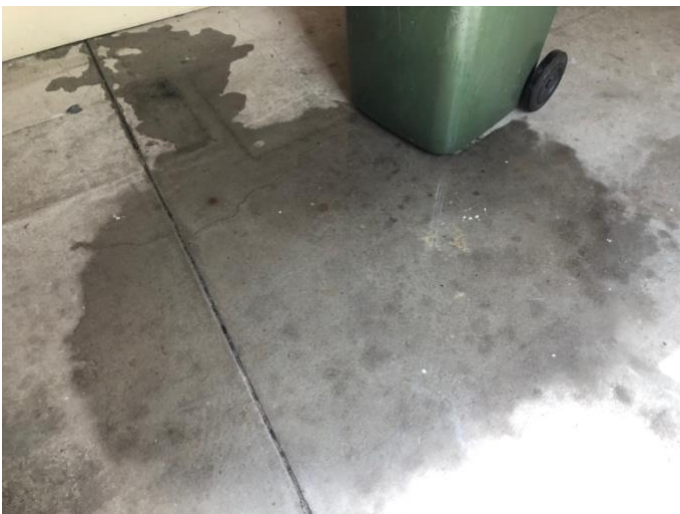
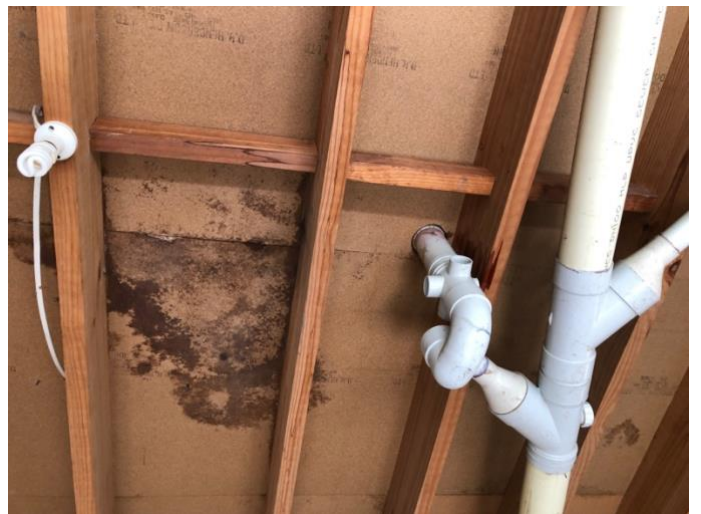
- The window and garage door are screwed closed.
- Minor cracking to the floor slab (typical).
- Undersize access tread goings noted; beware of trip hazards.
- Significant water escape noted from the upper-level bathroom as per the summary. (Photos page 11)

- One damaged timber balustrade requires replacement asap; beware of fall hazards. (Photo page 11)
- Water stain noted to ceiling. No abnormal moisture readings and no obvious avenue of ingress. (Photo page 12)
- Sliding door keeper required.
- Minor cracking noted to the wall lining adjacent door openings.

- Suspected water escape from shower recess and bath area as per the summary. (Photo page 11)
- Inconsistent fall to floor waste, cracked floor tile grout and general movement of the substrate flooring.

- Suspected water escape from shower recess and bath area as per the summary. (Photo page 11)
- Significant water escape noted from adjacent garage area. (Photo page 11)
- The vanity taps are seized.
- Minor cracking to the floor tiles adjacent the bath.

**We strongly recommend further inspection by a licensed plumber in relation to water escape from the upper-level bathroom areas, due to significant water escape via defective waterproofing/faulty pipework/plumbing. Removal of adjacent ceiling linings will be required.**

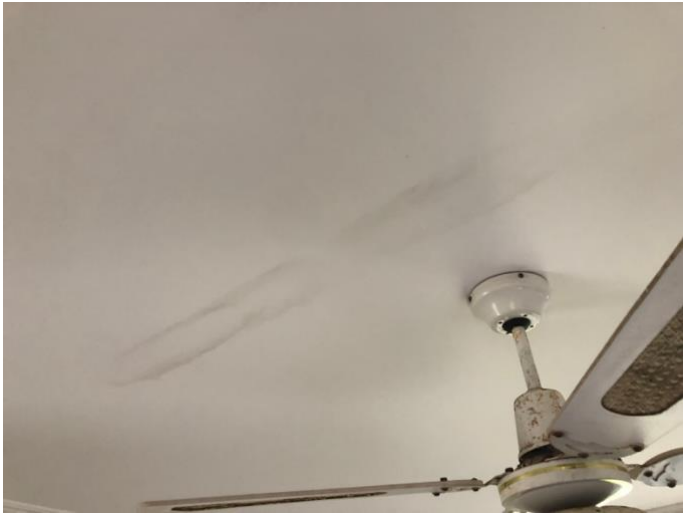
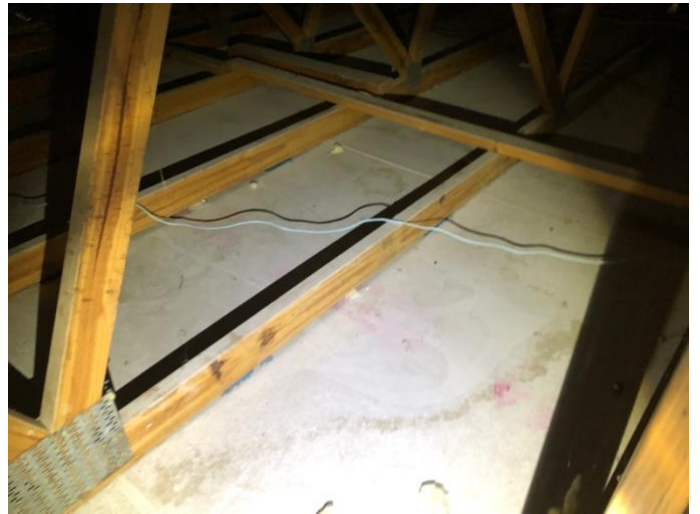
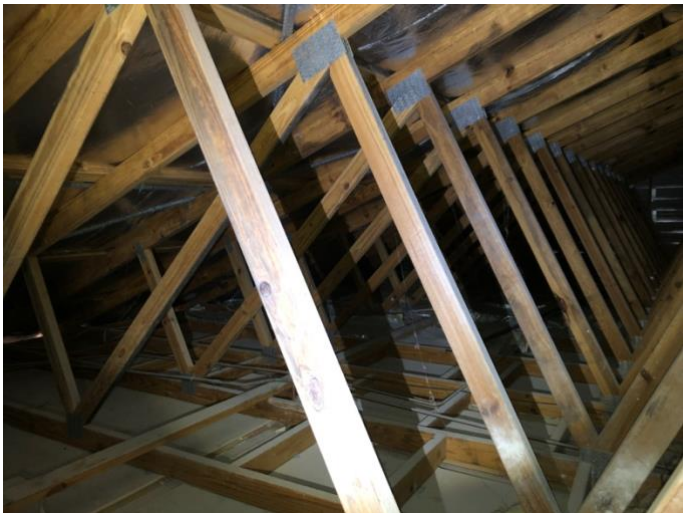
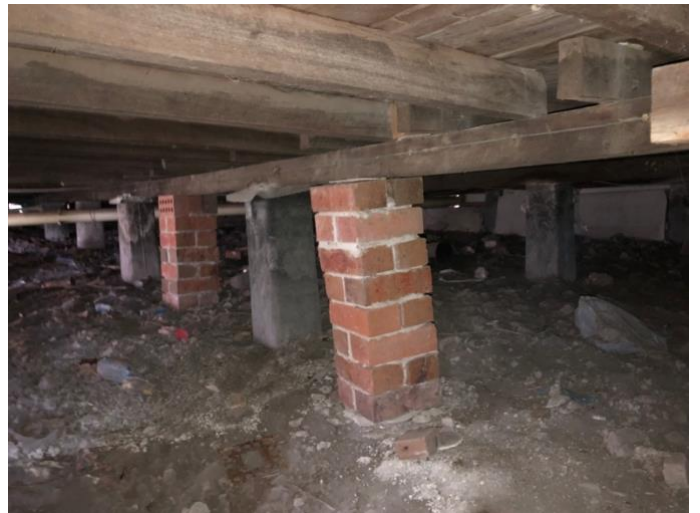
- The roof frame appears generally true and adequately braced. (Photo page 12)
- Insulation blanket installed to the underside of the roof sheets.
- No insulation batts installed over the ceiling linings.
- No roof ventilation noted.

- Pier improvements recommended adjacent the lounge/dining floor area as per the summary. (Photos page 12 & 13)
- Sections of the perimeter sub-wall brickwork were not constructed with attached piers; however, however, no structural issues noted. (Photo page 13)
- Area of significant water damage to flooring and frame adjacent the ground floor shower recess. Repairs only possible with renovation of bathroom. (Photo page 12)
- Water noted tracking down sewer riser pipe adjacent bathroom area. (Photo page 13)
- Adequate ventilated.

**Significant settlement and spalling were evident to the isolated piers under the lounge/dining room area, including makeshift brick pier additions. Allow substantial monies to replace the defective piers. Consult a licensed builder.**
