# Inspection Report

## All Round Pest Management

**21 Master Street, Belmont, NSW, 2280**

## TIMBER PEST INSPECTION

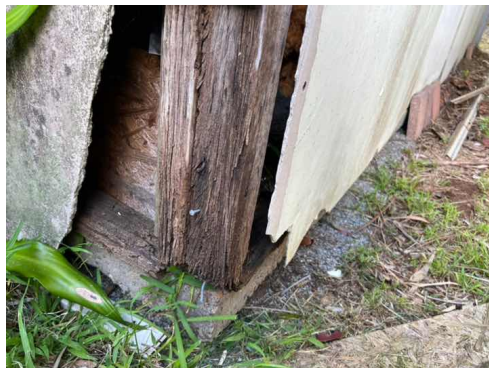
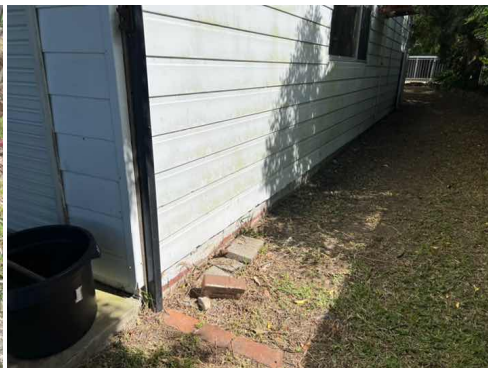
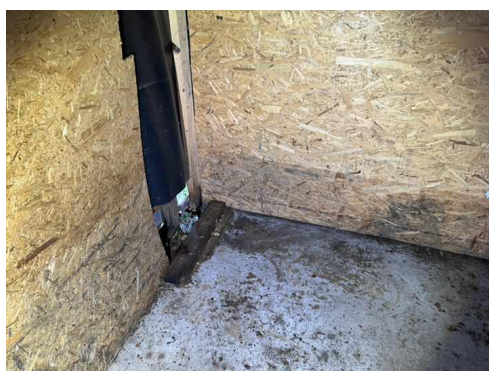
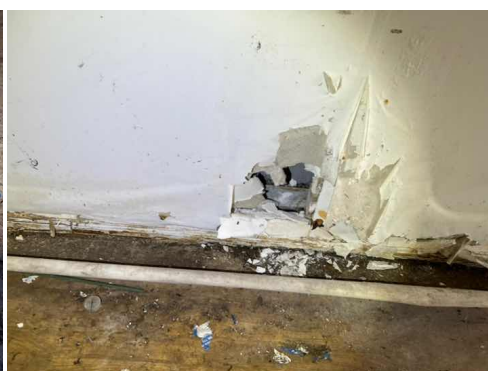
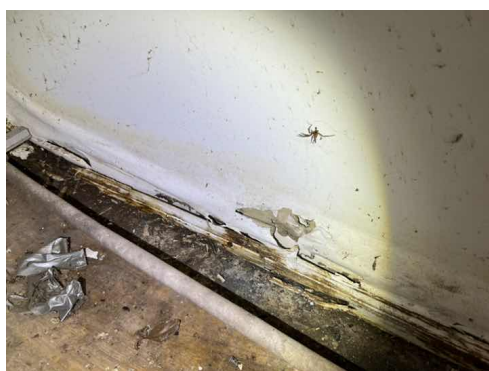
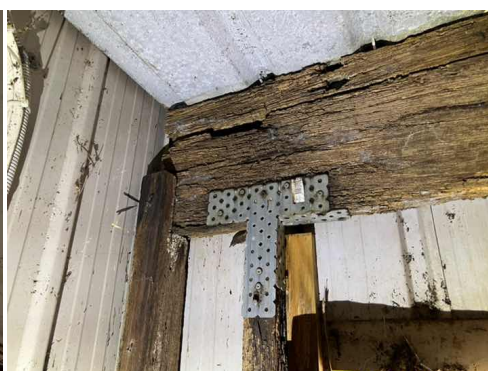
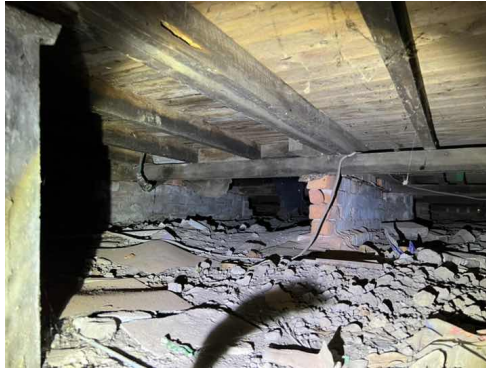
Garden timbers

Garage wall frame.

Moderate Damage

Areas of moderate decay will require sections of timber to be replaced. Where there is severe fungal decay the entire affected timber member should be replaced, preferably with treated hardwood.

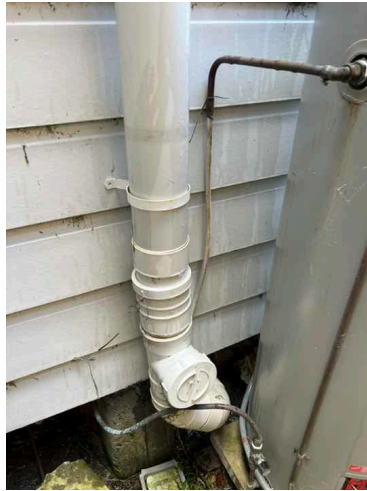
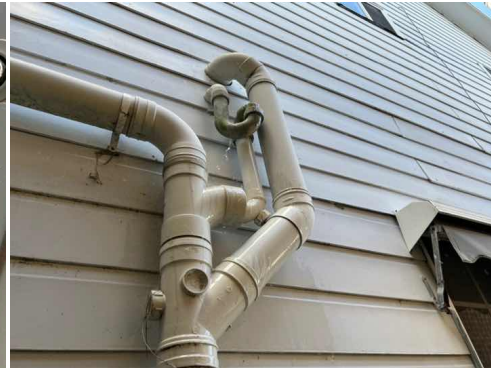
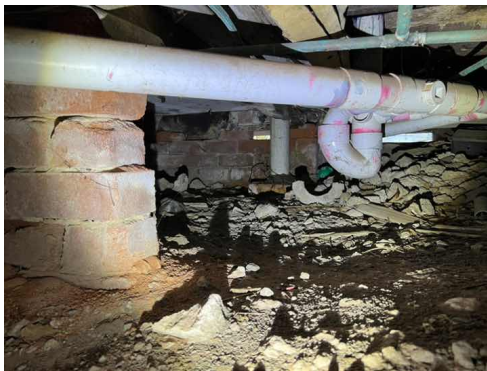
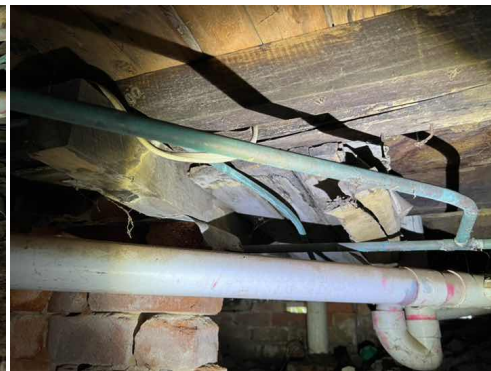
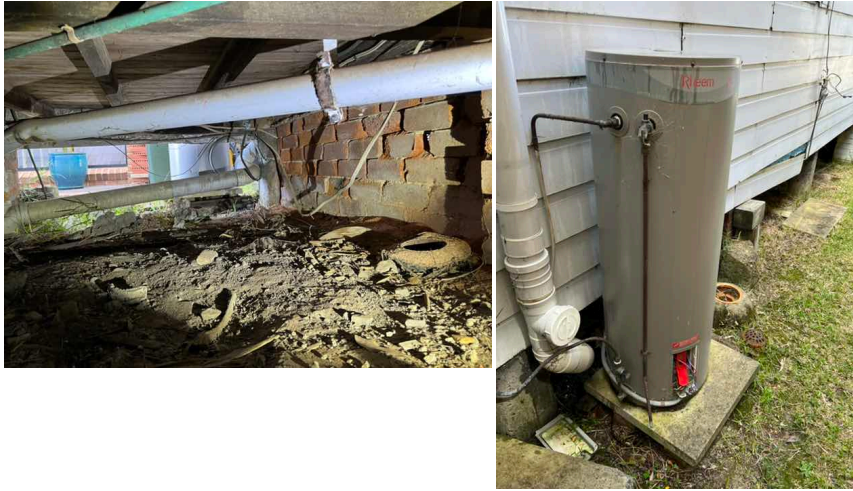
There was water leakage detected during the inspection that appeared to be emanating from the bathroom/ shower recess. Recommendations: Consult an appropriate trade for a scope of works and cost of repairs for the issue prior to contracts becoming binding.

There was water leakage detected during the inspection from the hot water overflow. This should be diverted away from the dwellings walls or into a drain.

There was water leakage detected during the inspection from some plumbing pipes in the sub floor. Consult an appropriate trade for a scope of works and cost of repairs for the issue prior to contracts becoming binding.

There was water leakage detected during the inspection from the tap. Consult an appropriate trade for a scope of works and cost of repairs for the issue prior to contracts becoming binding.

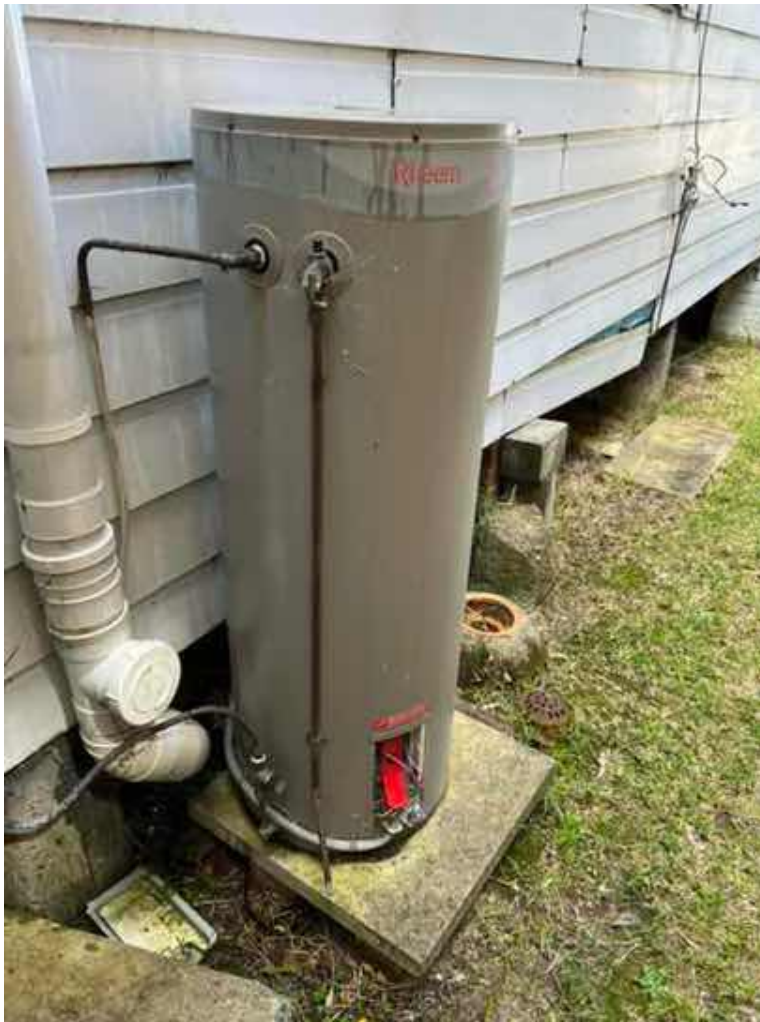
No - Divert hot water overflow away from the building perimeter

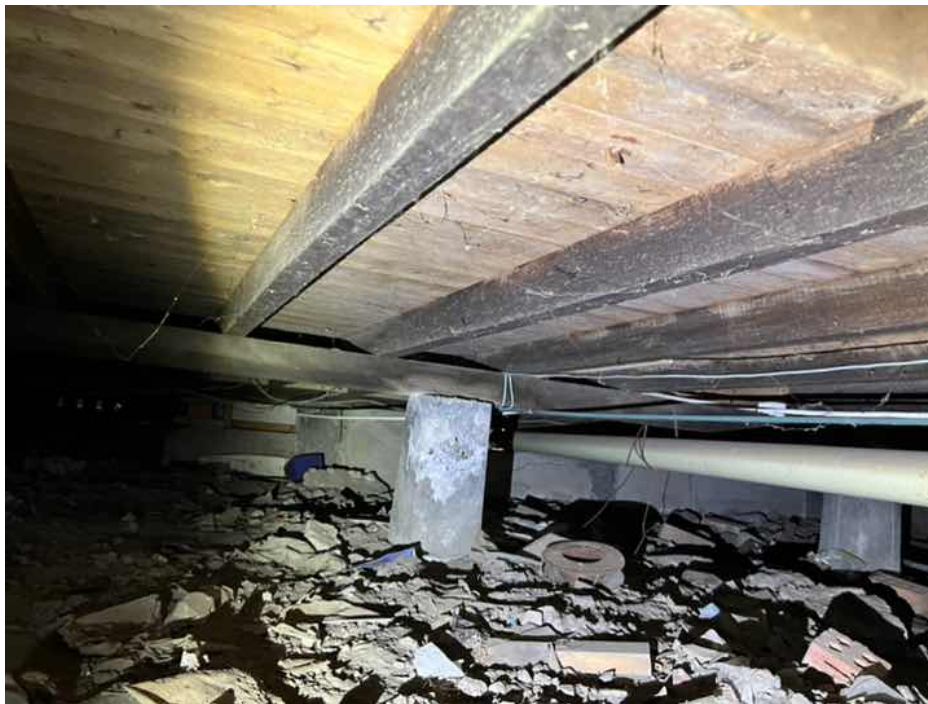
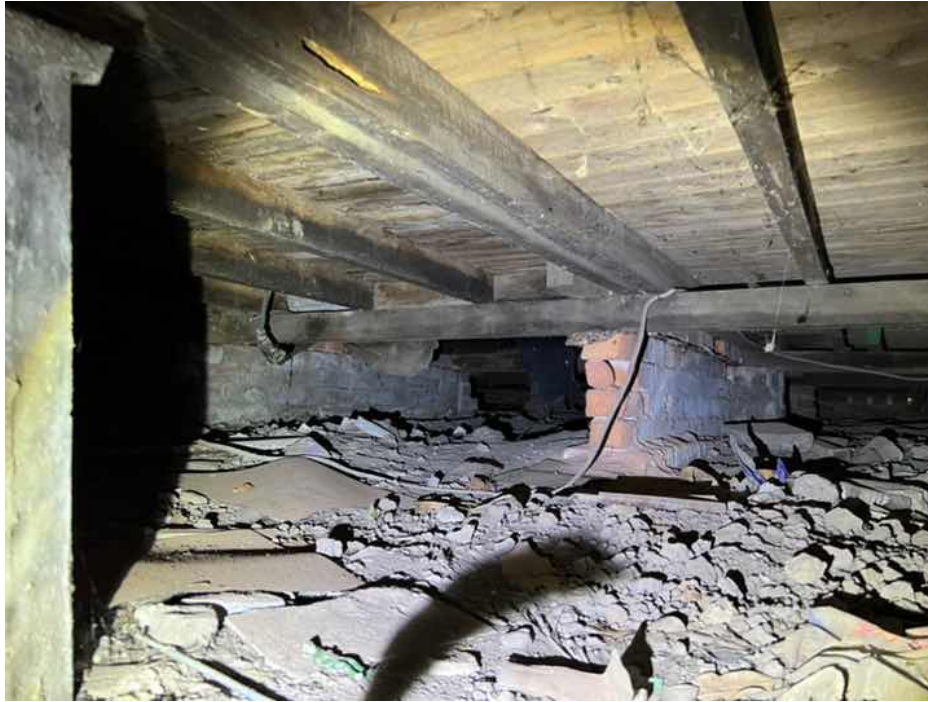
The termite shields (ant caps) are inadequate. Consult an appropriate trade for a scope of works and cost of repairs for the issue prior to contracts becoming binding.

Some ant caps missing some rusted out

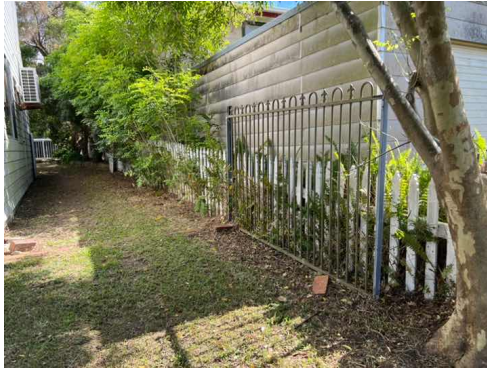
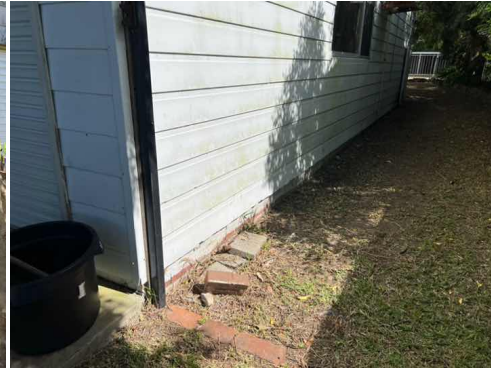
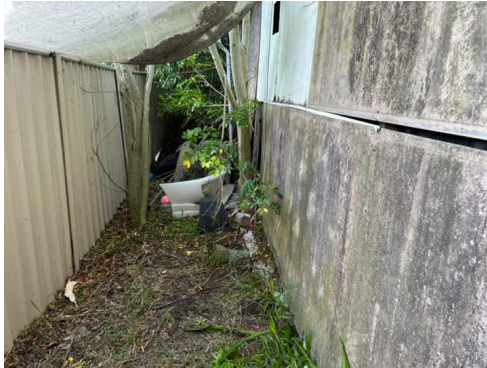
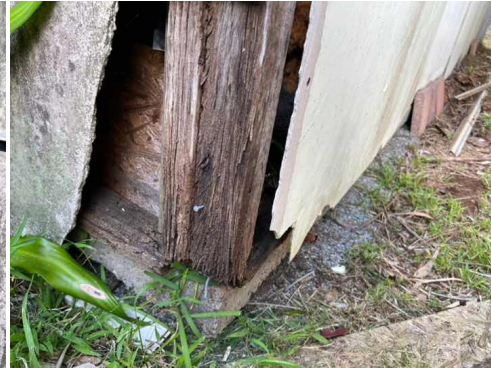
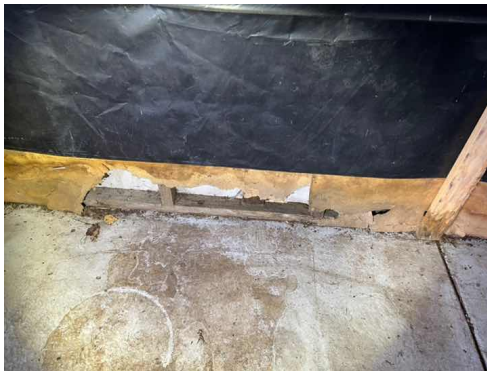
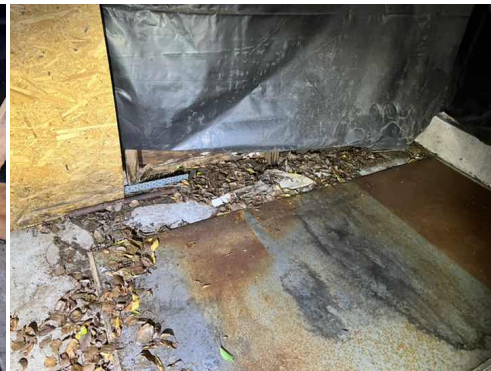
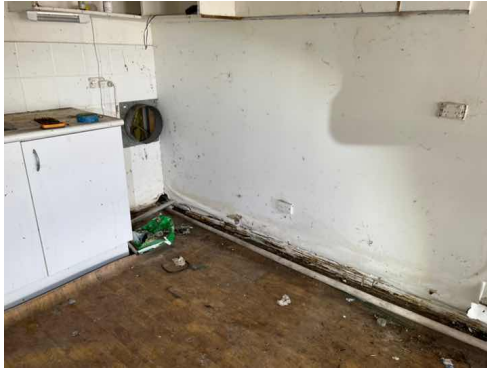
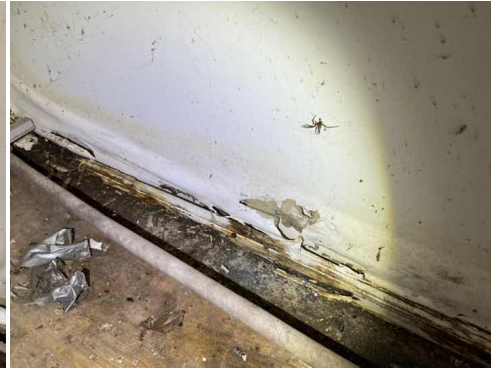
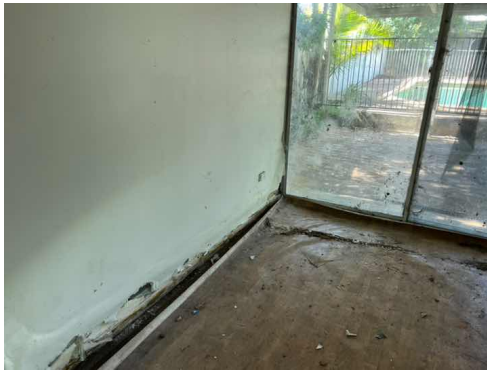
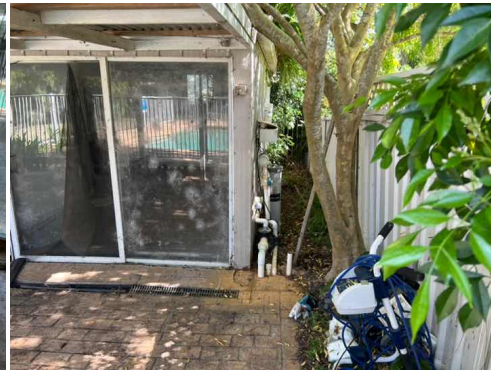
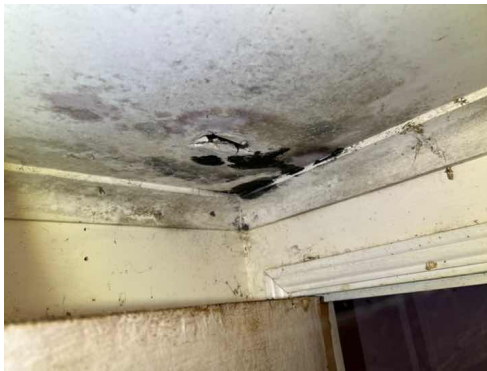
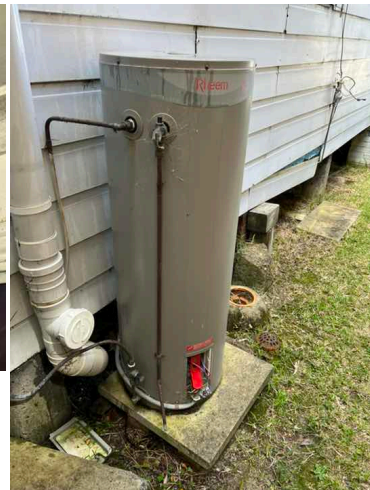
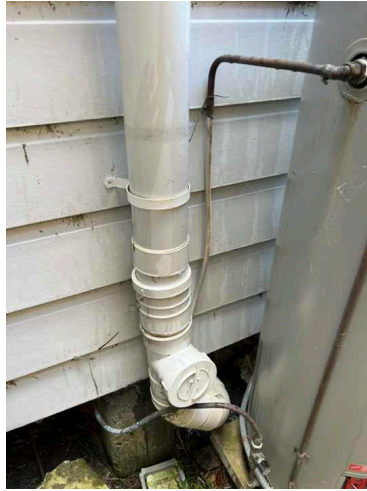
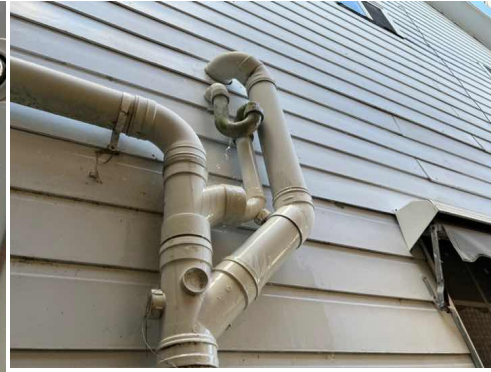
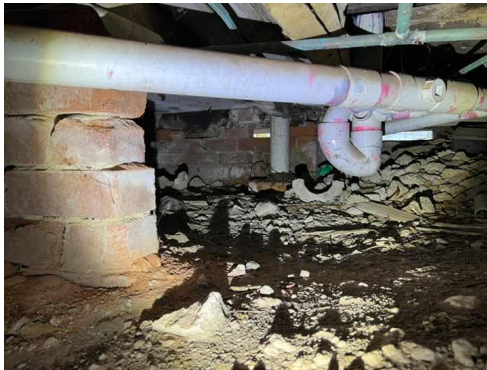
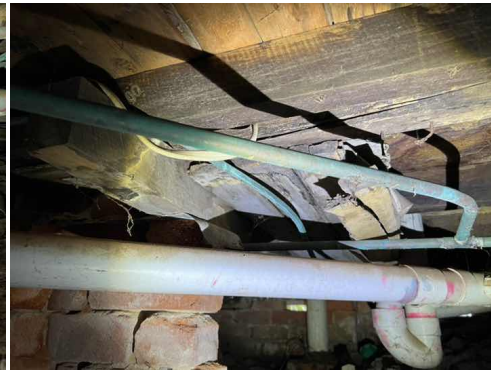
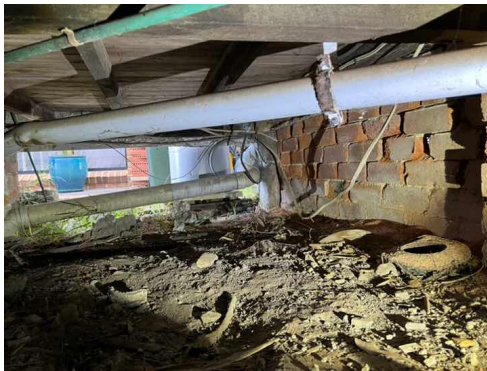
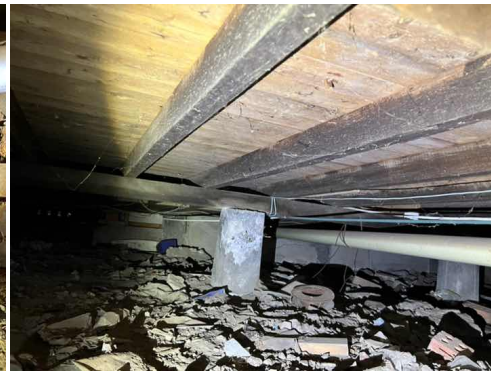
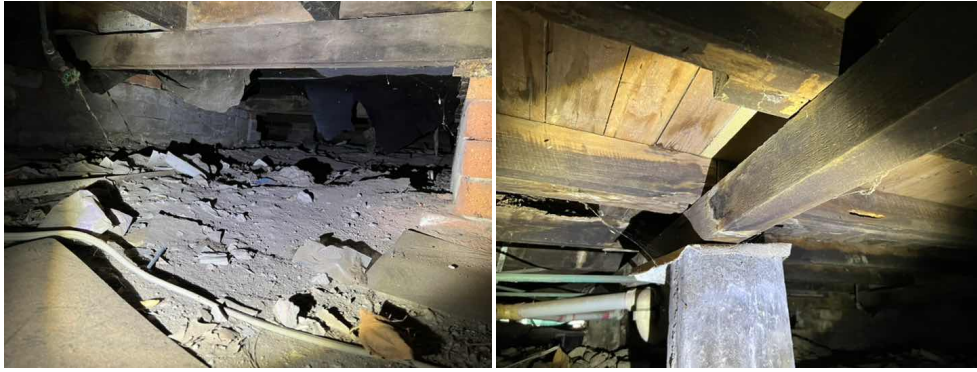
Wall mounted air conditioner overflow requires diverting to drain. This provides conducive conditions for termite infestation.

Damp sub floor soil. This provides conducive conditions for termite infestation. Consult an appropriate trade for a scope of works and cost of repairs for the issue prior to contracts becoming binding.

Timber framing in contact with ground in sub floor due finished ground levels high and being built close to ground. This provides conducive and concealed conditions and concealed entry for termite infestation.

Hot water unit overflow not connected to drain. This provides conducive conditions for termite infestation.

Leaking bathroom into subfloor timbers. This causes moisture and excess moisture is conducive to termite infestation. Consult an appropriate trade for a scope of works and cost of repairs for the issue prior to contracts becoming binding.

Leaking plumbing under home. This provides conducive conditions for termite infestation. Consult an appropriate trade for a scope of works and cost of repairs for the issue prior to contracts becoming binding.

Timber debris in contact with ground in sub floor. This provides conducive and concealed conditions for termite infestation.

The fence is in contact with soil in areas. This is conducive to decay and termite attack. Consult an appropriate trade for a scope of works and cost of repairs for the issue prior to contracts becoming binding.

Timbers in direct contact with soil creates conducive conditions for termite attack. Timbers should be removed or replaced with a product resistant to termite attack.
